USA-CERL TECHNICAL REPORT N-88/06  
April 1988

# Evaluation and Guidelines for the Use of Temporary Wood Buildings at U.S. Army Installations

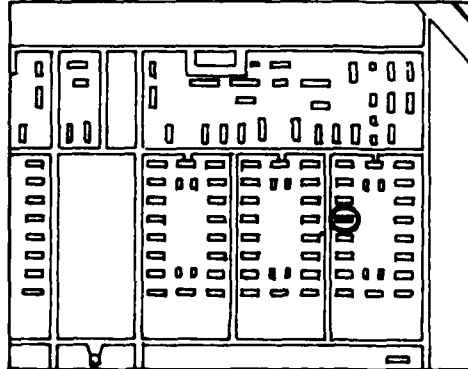
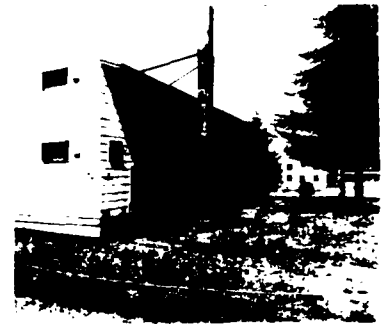
4.1

- 4.1.1 External Lighting
  - none, only a firelight
  - street light a security issue: more lighting would give a feeling of greater safety
- 4.1.2 Recreation Areas
  - barracks are near gym
  - have volleyball court
  - facilities judged adequate by users
- 4.1.3 Courtyards
  - need to be blacktopped
  - dust blowing into buildings is a problem in the summer when trucks use the quadrangles
- 4.1.4 Lawns
  - no comments recorded
- 4.1.5 Parking
  - nearest parking : 100 meters from barracks
- 4.1.6 Landscaping
  - none
- 4.1.7 Garbage Bins
  - if dumpsters were closer to barracks users would empty trash more often

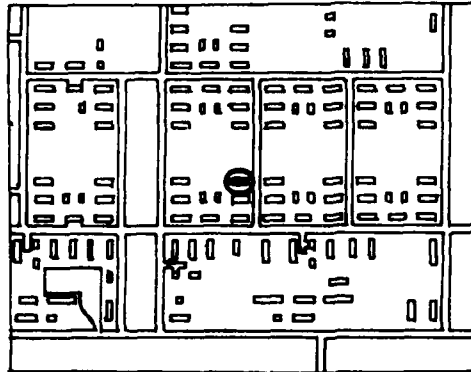
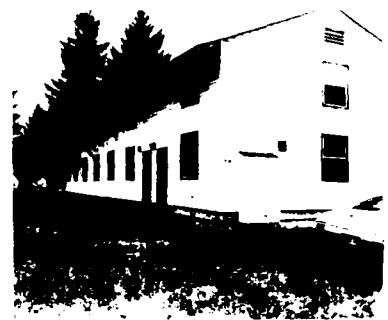
5.1

- 5.1.1 External Lighting
  - adequate night lighting
- 5.1.2 Recreation Areas
  - adequate basketball and baseball
- 5.1.3 Courtyards
  - social activity takes place in space between buildings
  - can use space for barbeques and car washing
- 5.1.4 Lawns
  - not able to walk on grass-roped off
  - would prefer being able to use grass
- 5.1.5 Parking
  - plentiful and convenient
- 5.1.6 Landscaping
  - nothing except grass
  - existing trees provide shade
  - roots cause problems with sidewalk cracking
  - trees too close to building could cause foundation problems
- 5.1.7 Garbage Bins
  - scattered throughout area in strategic spots

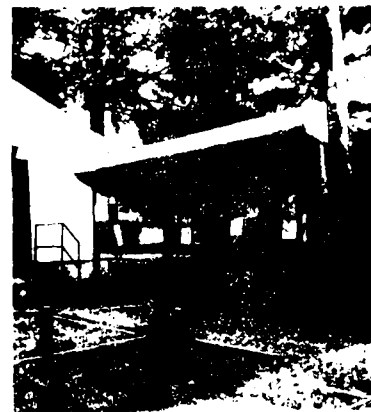
- 5.2.7 Notice Boards
  - public information board located outside building and in mess hall
- 5.2.8 Fire Extinguishers
  - information readily available
- 5.2.9 Living
  - common area would be nice in building
  - necessary to go to next building presently, a problem, especially in rain
- 5.2.10 Furnace Room
  - creates heat problem in rooms above it

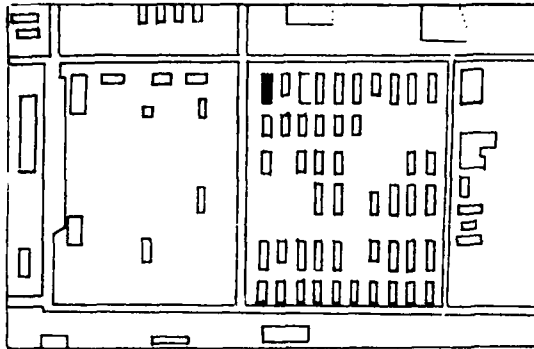
4.1

- 4.1.1 External Lighting
  - no comments recorded
- 4.1.2 Lawns
  - no drainage problems around perimeter of building
- 4.1.3 Parking
  - on street parking cited as adequate
- 4.1.4 Garbage Bins
  - located adjacent to building: said to be convenient
- 4.1.5 Pedestrian Walkways
  - concrete walks between buildings: recently repaired/replaced as needed
- 4.1.6 Surfaces
  - sunlight and heat require steel siding to reduce deterioration/rot
  - no storm windows are used: payback period (20 years) is considered to be too long
  - some roof sagging has occurred due to overloading with shingles
  - no leakage problems with roof
  - when renovated, building made weathertight: fresh air exchange in furnace room provided to prevent potential

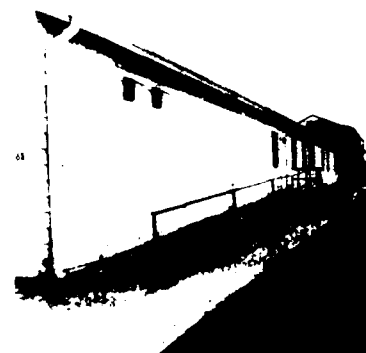
4.3.1

- building is entirely handicapped accessible
- fountains and latrines designed for handicapped use
- four exits, one on each side of the building
